CITY OF LODI COUNCIL COMMUNICATION

AGENDA TITLE: Receive Report Regarding Status of Mokelumne River Bank in the General Vicinity of Pigs Lake within Lodi Lake Nature Area

LODI LAKE PARK - **PIG'S LAKE** PROPOSED LEVEE REPAIR PROJECT

Re: Lodi Lake Nature Area Erosion Along Mokelumne River

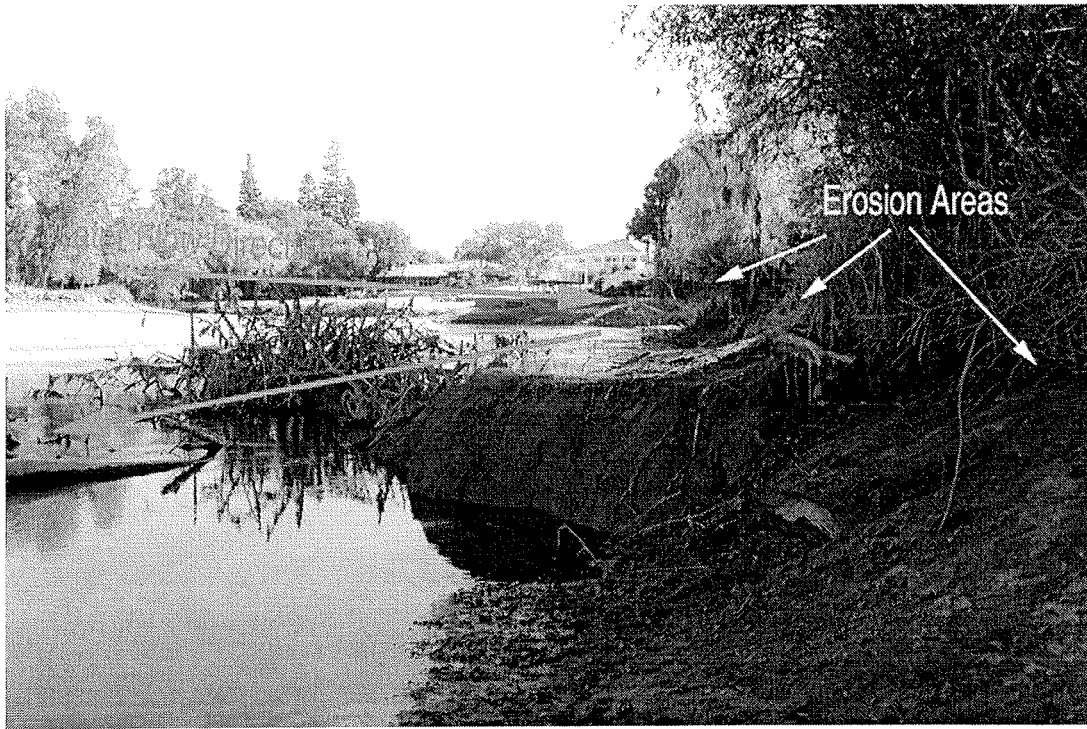
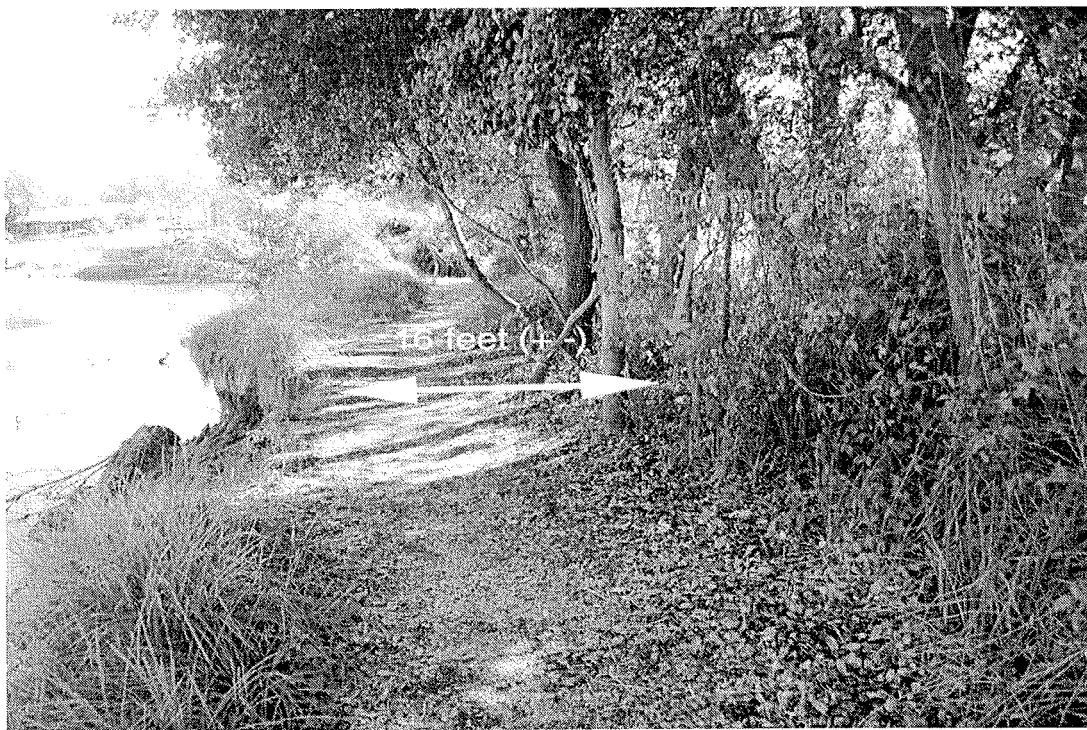
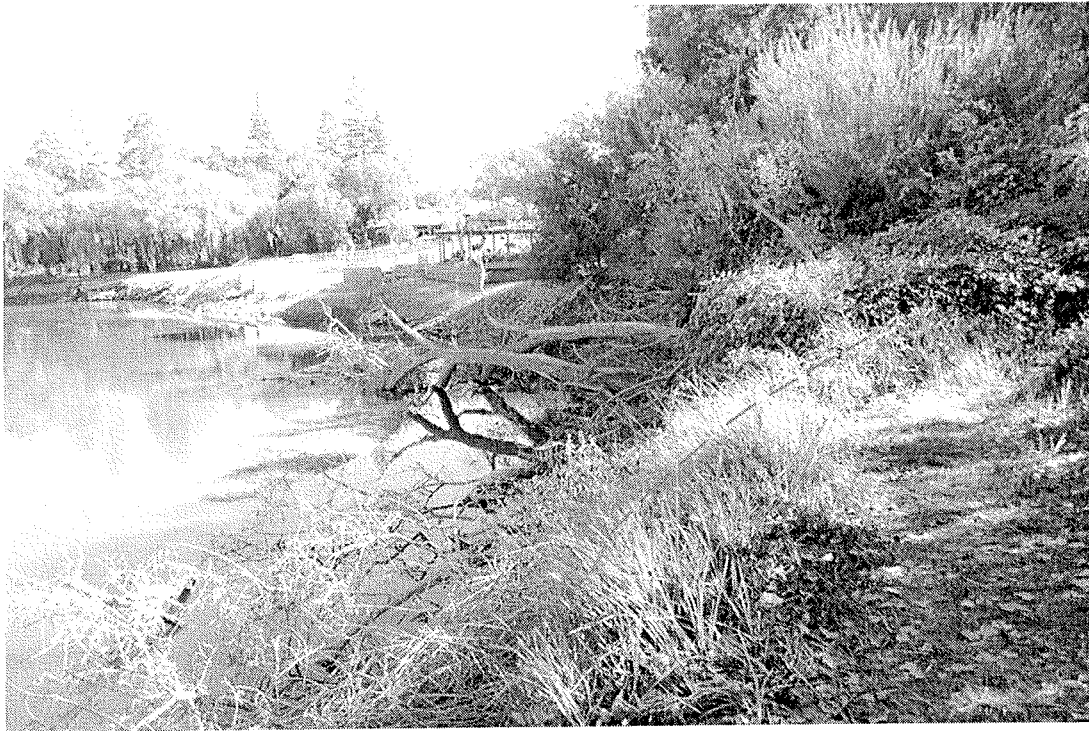
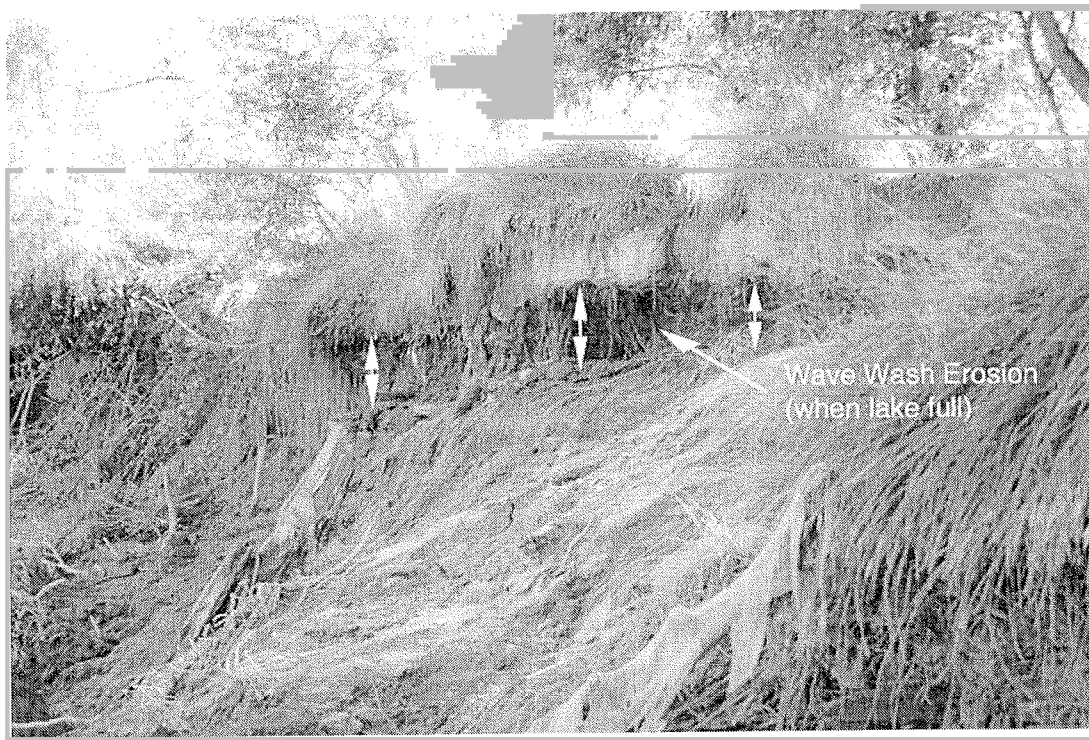
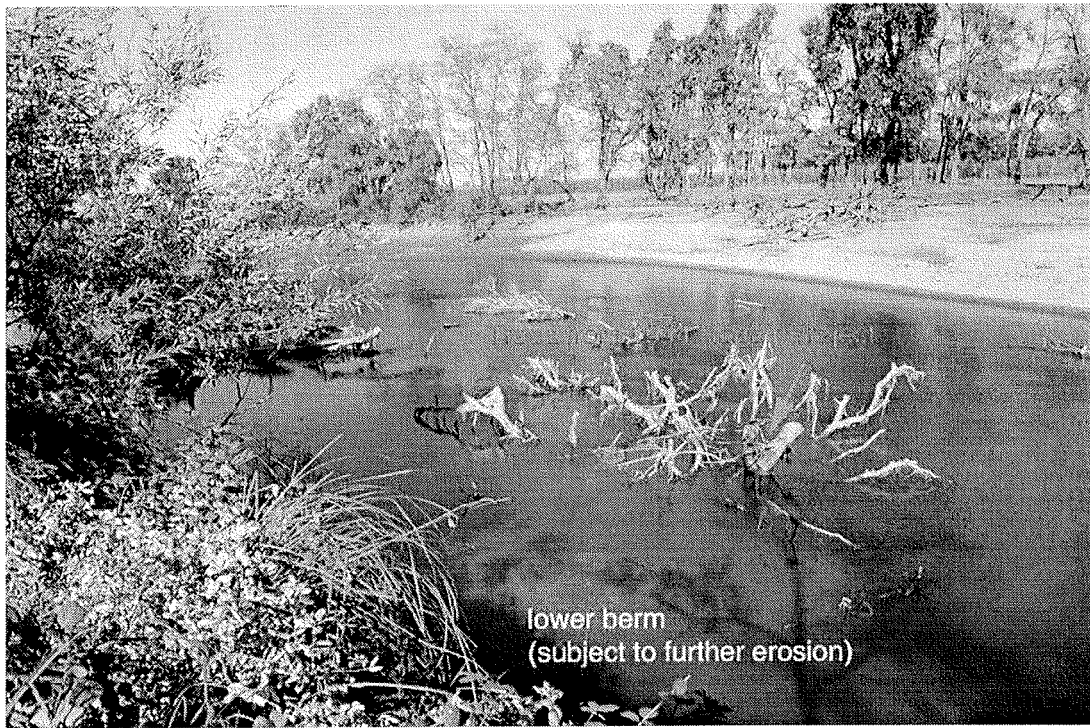
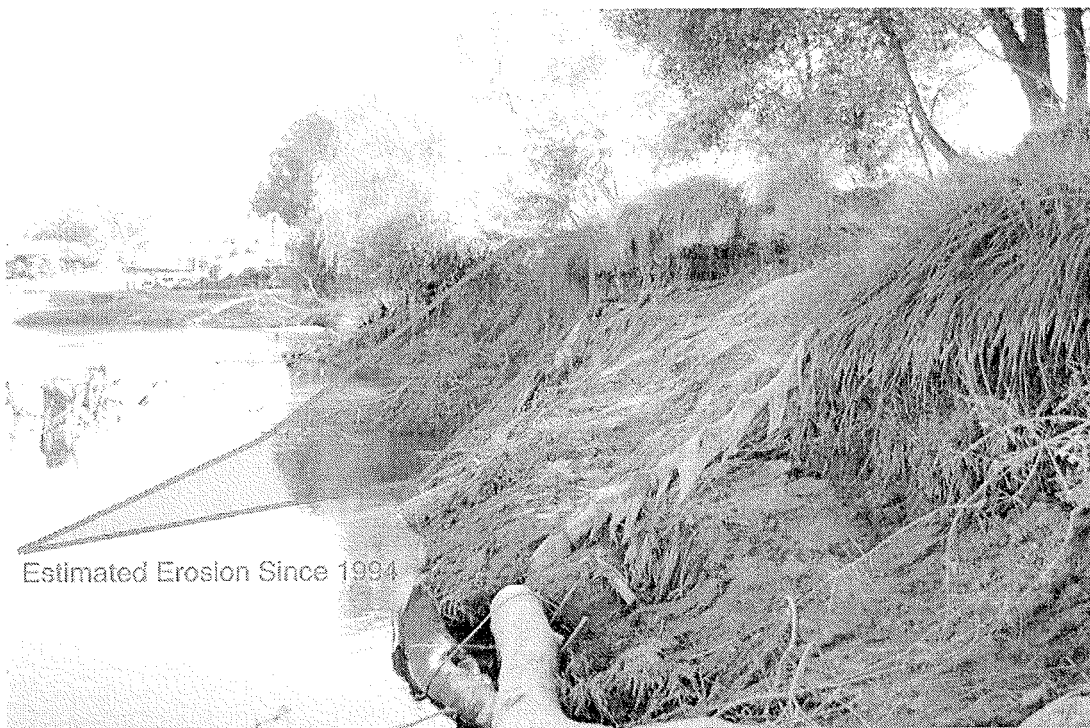
Lodi Lake Park
Molteluinne River/Pig Lake Erosion Sites

As shown in the attached photos, erosion has occurred on the right bank of the Mokelumne River upstream of the Lodi Lake dam in the vicinity of Pig Lake. The erosion site is approximately 300 feet in length and is located just downstream of a 180 degree bend in the River that causes the lower portions of the river bank at the site to be exposed to the hydraulic cutting action of the river. Erosion is occurring higher up on the river bank slope at the waterline due to wave run up from the wakes of watercraft. This wave erosion has caused undercutting of the bank up to 3 feet in some places. The soil at the site is predominately a cohesionless, fine silty sand that erodes quite readily.

First, there is hydraulic erosion occurring below the waterline that has undermined and washed out a previous repair project that was completed in 1994 (see attached drawings dated 12/93). The erosion area is located on the outside of a bend in the river, where velocities tend to be the greatest. The previous repairs appear to have consisted of stacking a grid of tree roots and logs along the eroded bank and cabling them to existing live trees along the shoreline. Remnants of the trees and logs used for the 1994 repair project remain scattered throughout the river bottom and bank of the site as shown in the attached photos. The remnant trees and logs may be aggravating the hydraulic cutting action of the river as they could be creating eddies and turbulence that are contributing to the erosion of the river bank.

Second, there appears to be wave wash erosion occurring at the summer water line when Lodi Lake is full. The waves are generated by both boats and wind. This erosion is clearly defined and localized at the top of the waterside slope. The wave wash was observed during the August inspection when watercraft passed the site.

Following a review of the 1994 repair project plans and the inspection observations, it is estimated that approximately 4 to 10 feet of the embankment crest has eroded away. In some places less than 15 feet of riverbank separate the river from Pig Lake.
